# PRODUCT BULLETIN

Australia Pacific Asia – May 2021

## DETONATOR MISFIRES DUE TO DYNAMIC PRESSURE OPEN CUT & QUARRIES

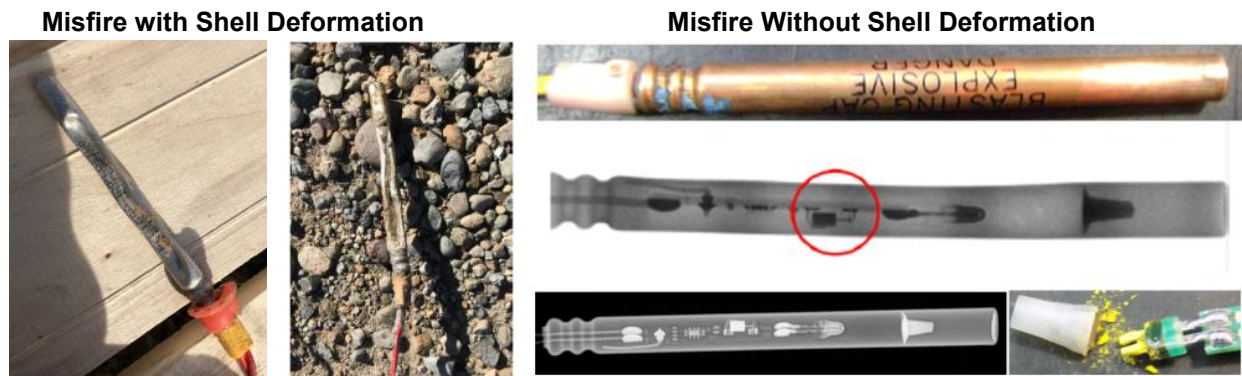
Dynamic pressure failures in electronic detonators are often referred to as 'shrink-wrapping' due to the detonator shell's appearance in some of these types of misfires. Misfires due to dynamic pressure can also occur due to damaged internal components of a detonator without visible shell deformation (see Figure 1)

Figure 1: Misfires caused by dynamic pressure, can occur both with and without obvious external shell deformation.
